## Investigation Summary Report Update 3

Date: 12 December 2017

This investigation is into the activities of heavy vehicle specialist certifier Peter Wastney and was initiated following a crash on 27 August 2017, where the catastrophic failure of a drawbeam on a truck JWN197 resulted in the detached trailer travelling a significant distance before coming to rest against a bank.

**RE: Drawbeam failure – Registration JWN197**

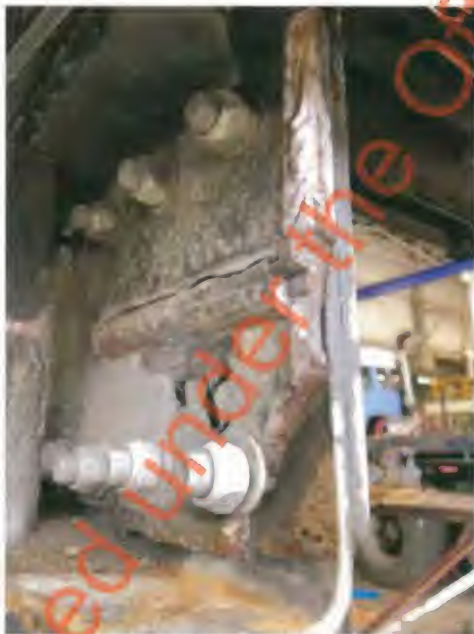
Inspection of the truck found that the drawbeam front weldment had separated from the side plates which affix the drawbeam to the chassis, Figure 2. The front weldment is made up of the front plate and upper and lower stiffeners, Figure 3.

Figure 2 Drawbeam side plates

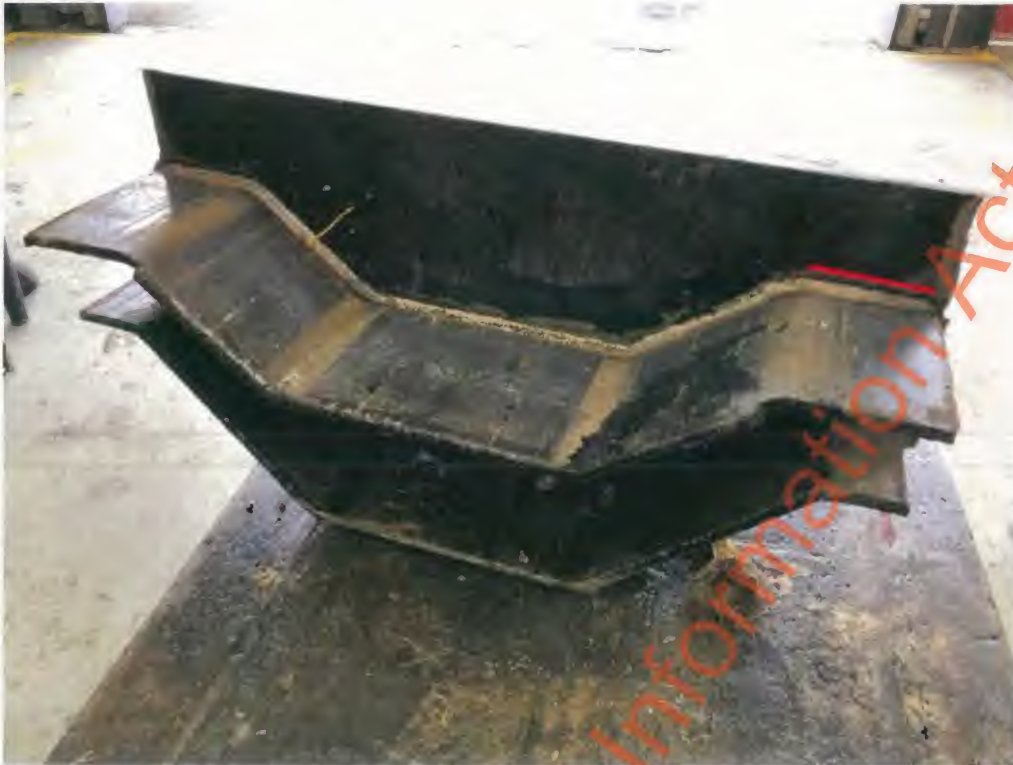
Figure 5 Drawbeam front section rear view, cracks below red line

In addition to the obvious fractures, there were cracks in the upper stiffener; left-hand side welded connection to the front plate, Figure 5 and Figure 6.

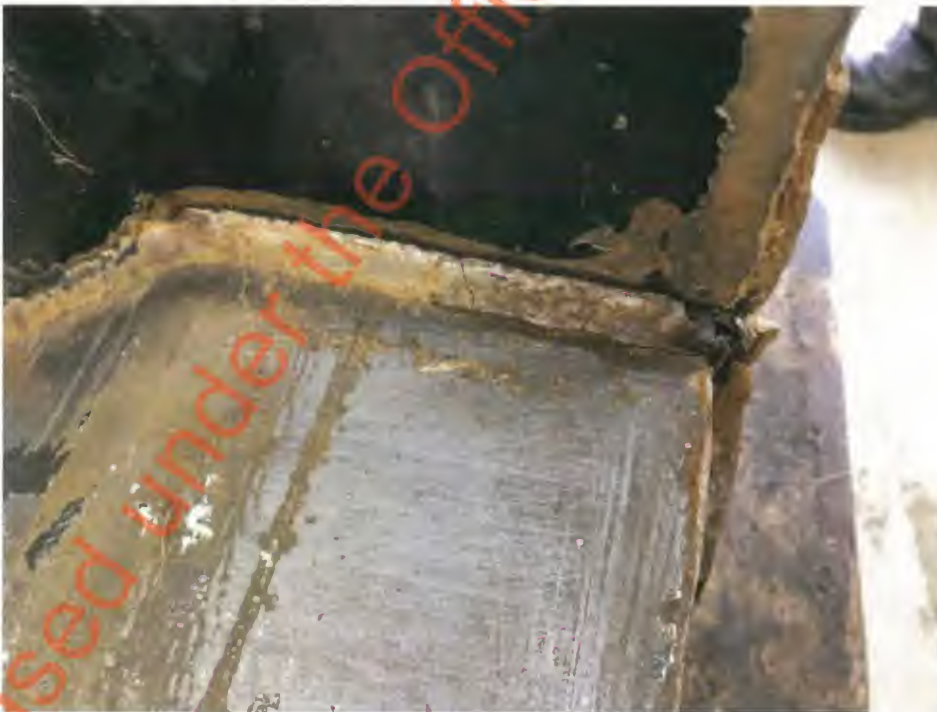
Figure 6 Cracks top stiffener to front plate

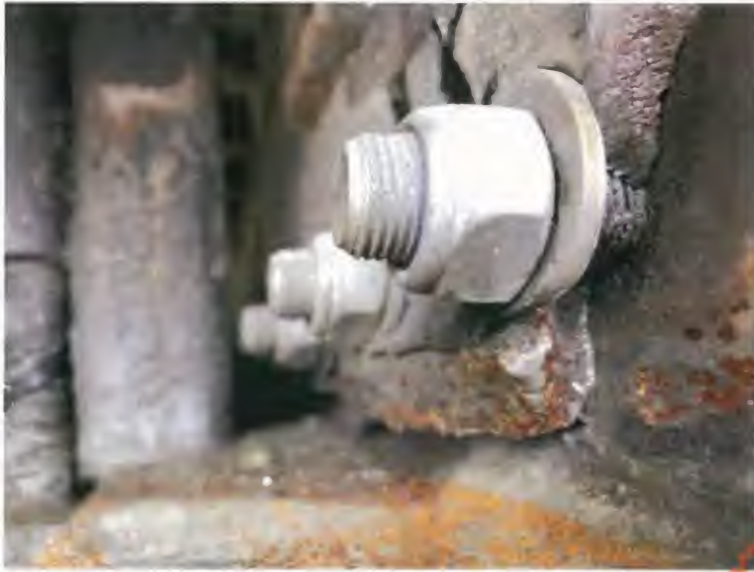
Several of the bolts in the drawbeam were seated incorrectly due to interference between the washers and welded connection, Figure 8.

Figure 8 Bolt seating interference

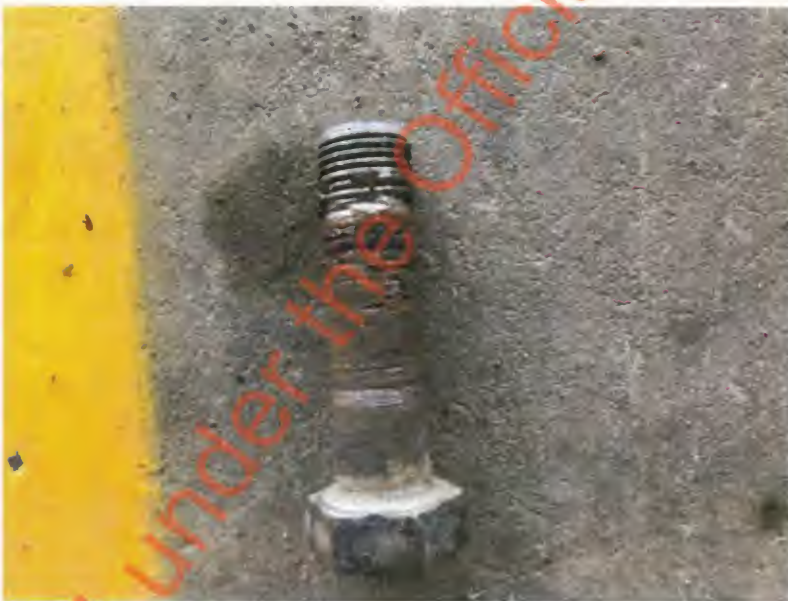
After removal of the bolts seated over the welds, the lower front bolts were found to be bent and showed thread damage, Figure 9.

Figure 9 Bend bolt with thread damage

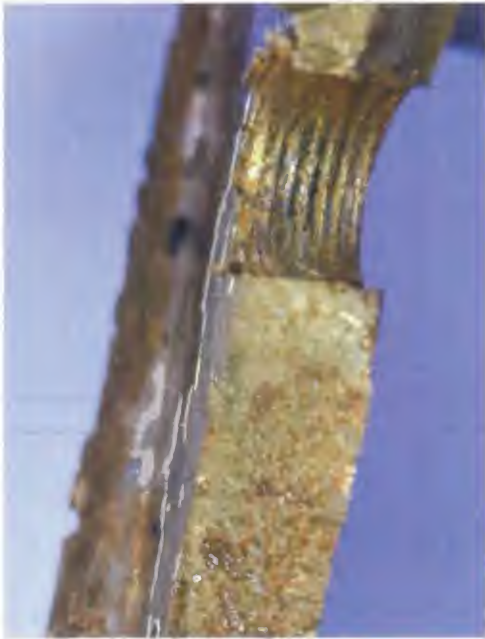
The internal faces of the front lower side plate holes also show the thread bearing marks, Figure 10.

Figure 10 Thread bearing marks

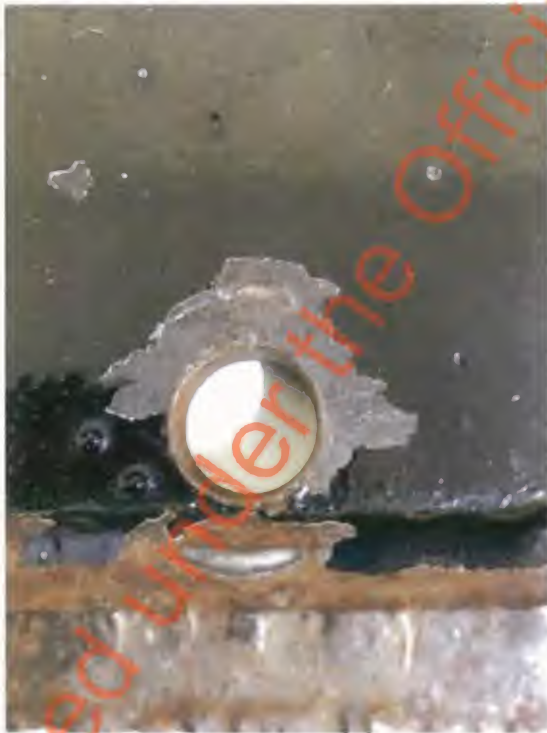
The bearing marks due to interference between a washer and the weld are shown in Figure 11.

Figure 11 Washer bearing mark

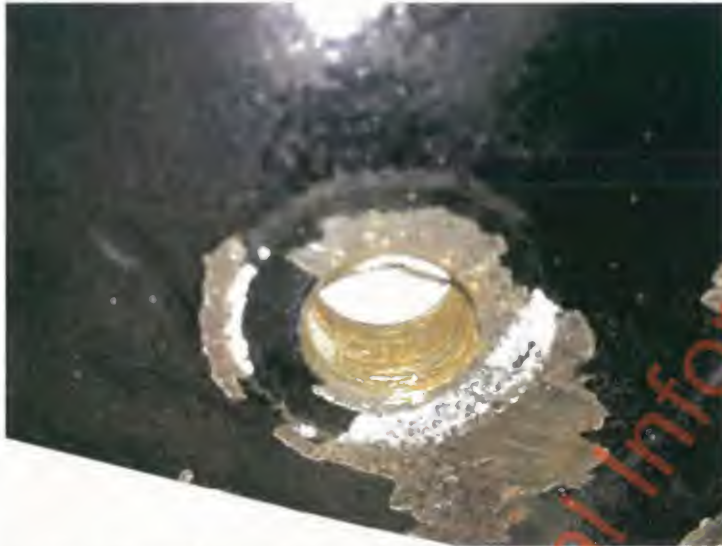
Most holes on the inside face of the side plates had burrs on their edges, Figure 12 and Figure 13.

Figure 12 Burrs on right-hand side plate, top front bolt hole

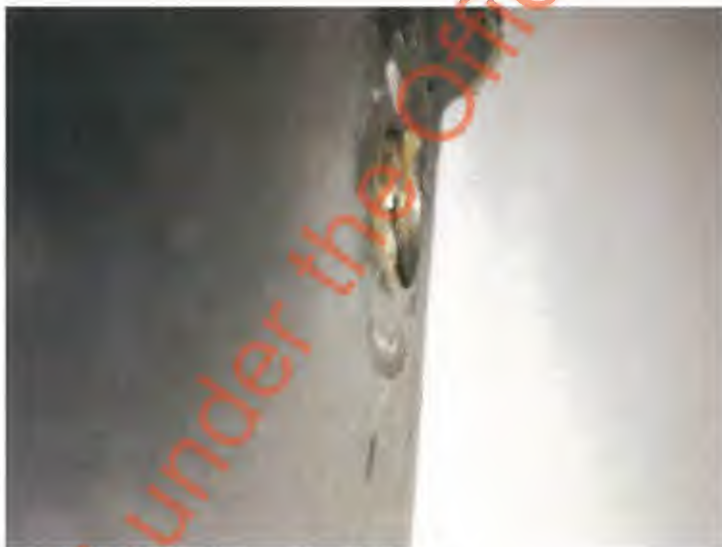
Figure 13 Burrs, looking down the side plate

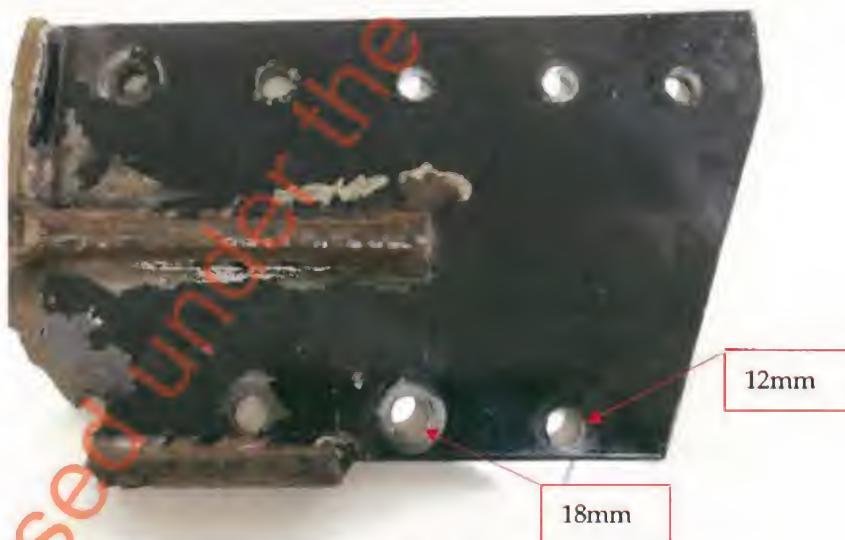
AS 3990 specifies a minimum edge distance from the centre of the fastener to the edge of the plate, typically 1.5 times the nominal diameter of the fastener, clause 9.6.2. For an M16 bolt, this would mean a minimum edge distance of 24mm. Two lower rear bolt holes on both sides of the drawbeam fail to meet this criterion, Figure 15.

Figure 15 Bolts not meeting minimum edge distance

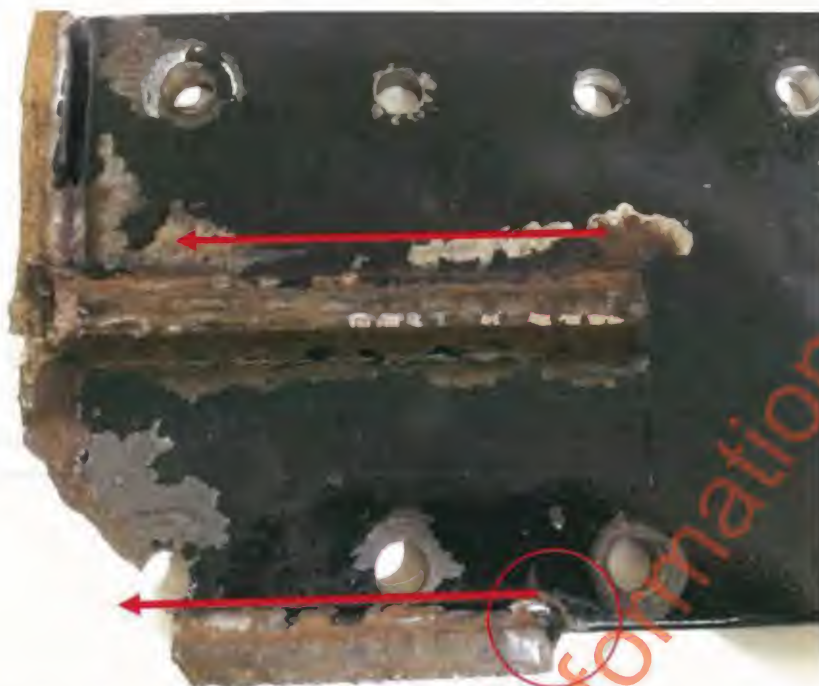
Evidence of fatigue in the drawbeam weldment was found (Figure 17). The fracture between the upper and lower stiffeners and side plate has occurred at the base of the weld toe in the parent metal; this is a typical area for crack initiation and propagation (Hobbacher, 2006). The crack initiation point seems to be located at the rear bottom stiffener plate, refer Figure 17 and Figure 18.

Figure 17 Side plate fatigue progression and initiation point (red circle)

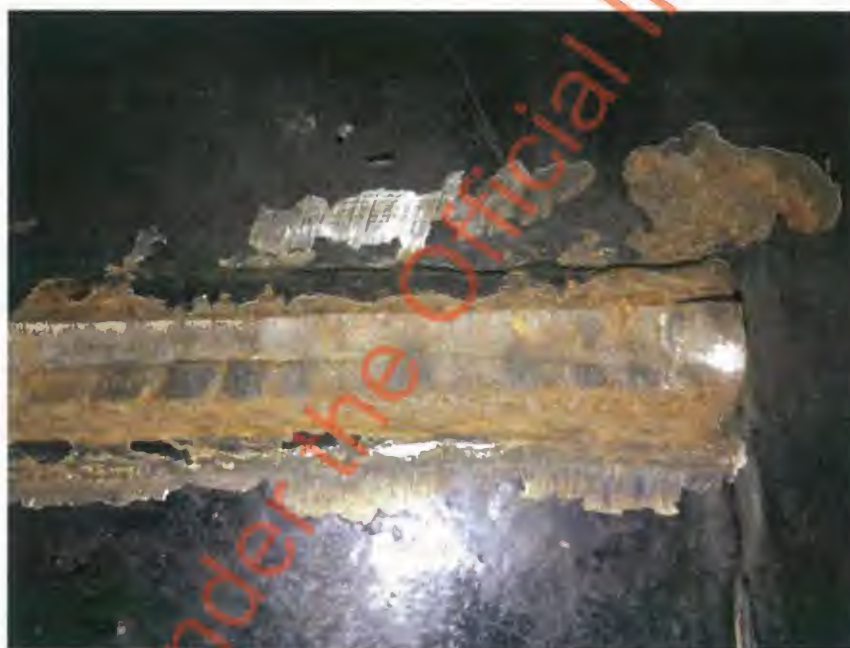
Figure 18 Plate crack propagation, stage II

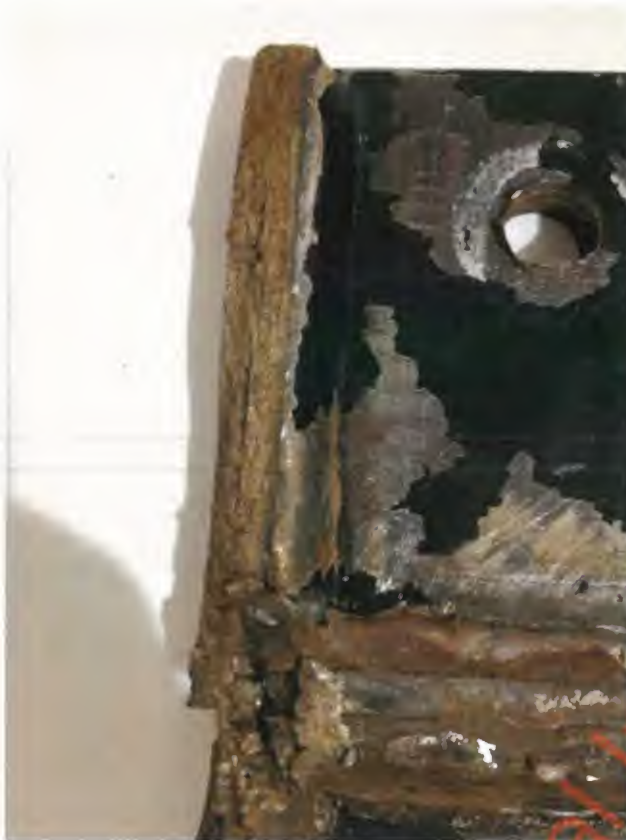
Stage 3 rupture indicators were on the front face of the drawbeam, Figure 19 and Figure 20.

Figure 19 Plate rupture markings, stage III

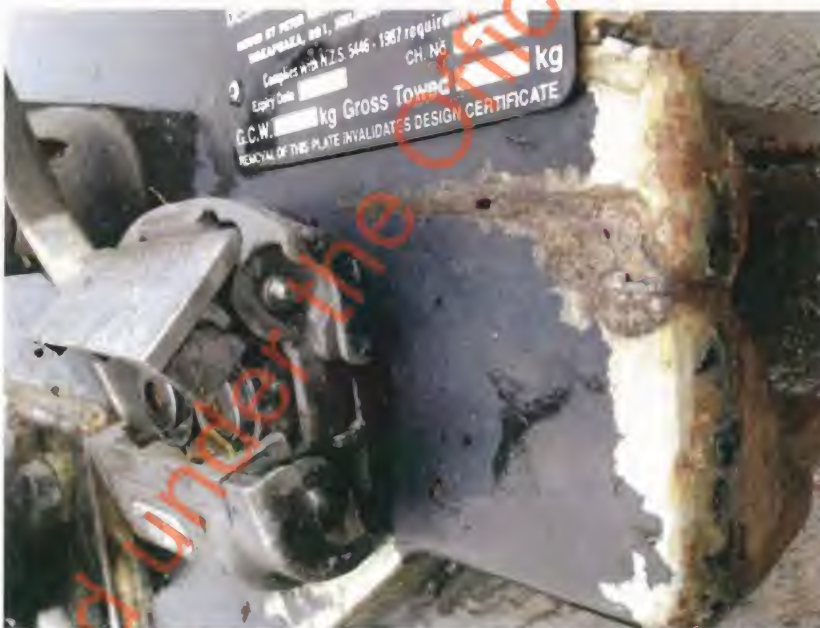
Figure 20 Plate rupture drawbeam face, stage III

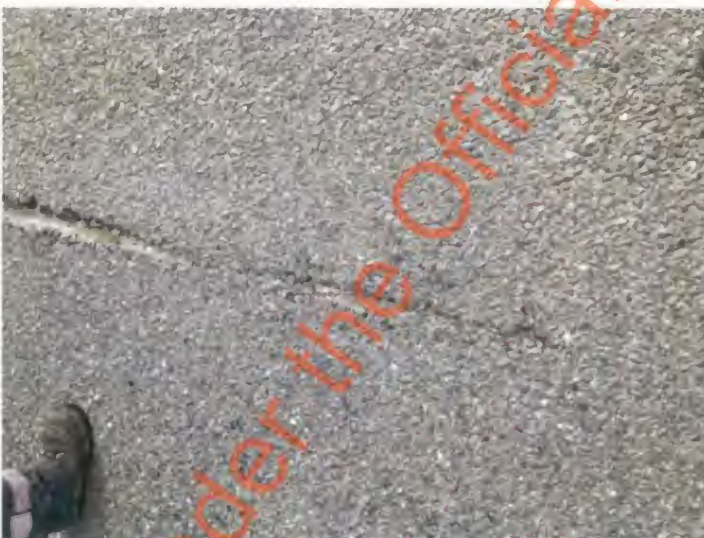
At the location where the trailer is reported to have separated from the truck, a prominent groove was found in the centre of the road lane, Figure 23 and Figure 24.

Figure 24 Groove on road surface

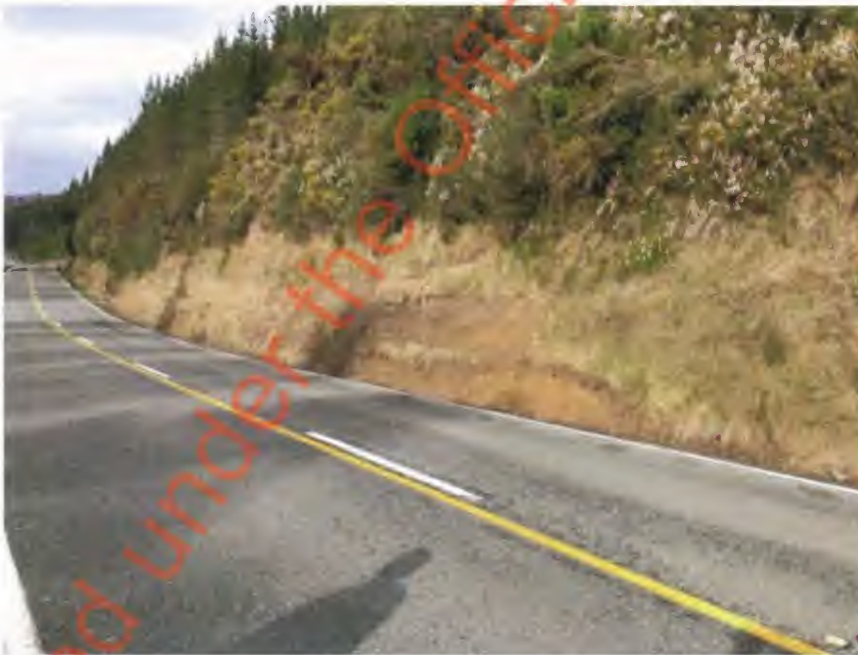
The trailer skidded along the embankment for approximately 40 metres before coming to rest, Figure 26.

Figure 26 Embankment collision marks

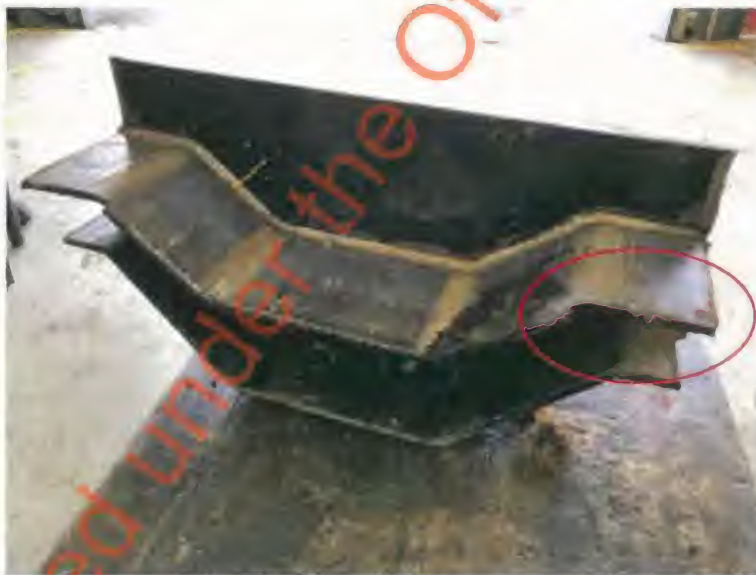
One area which may indicate some modification was a 10mm cut-out in the upper stiffener connection to the side plate. The cut-out is not identified in the drawing provided by the certifier, however, given the proximity between the upper stiffener and the crane attachment, it is likely this is as manufactured.

Figure 27 Cut-out in top stiffener

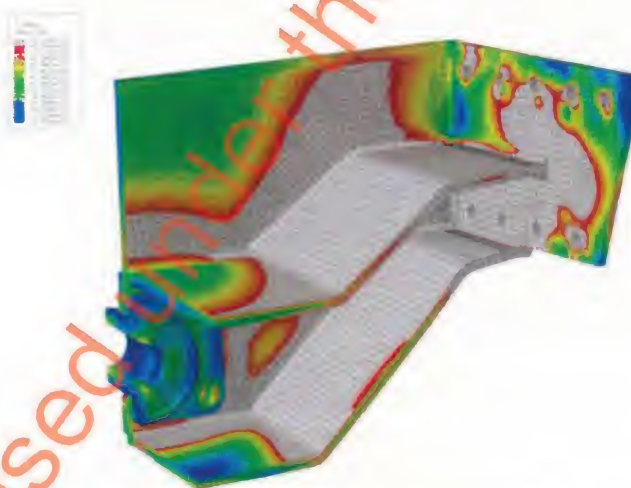
A 260kN load (for a 30,000kg MTM trailer) is applied to the Ringfeder attachment. The applied load caused large areas of the drawbeam to exceed the material yield stress, Figure 31.

Figure 31 von Mises stress, drawbeam 260kN load, areas in grey exceed 250 MPa

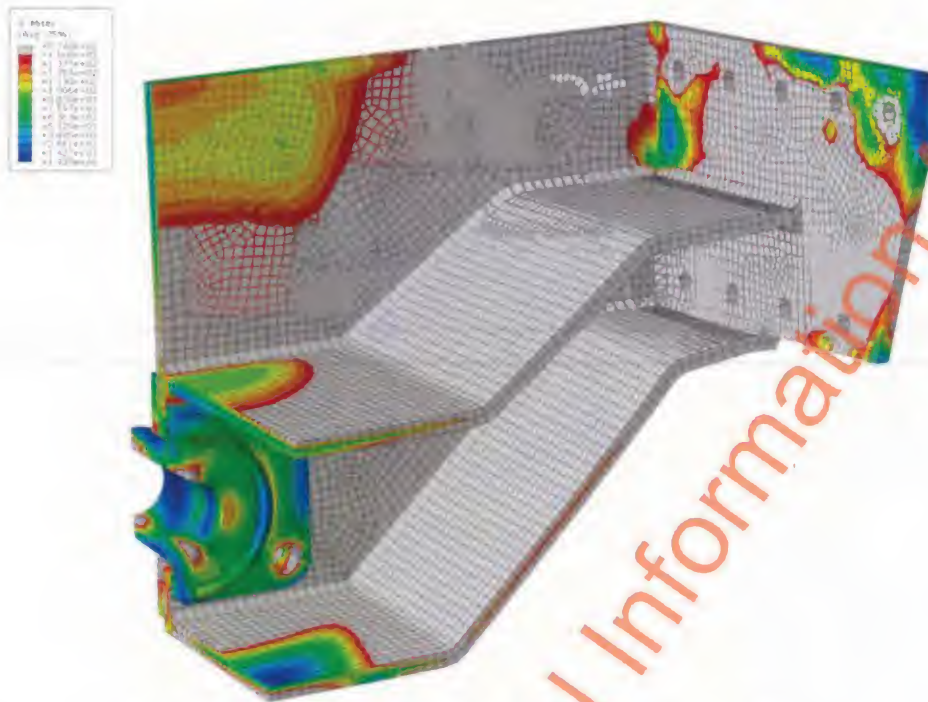
Large areas also exceed the maximum permissible stress of 150 MPa, Figure 32.

Figure 32 von Mises stress, drawbeam 260kN load, areas in grey exceed 150 MPa

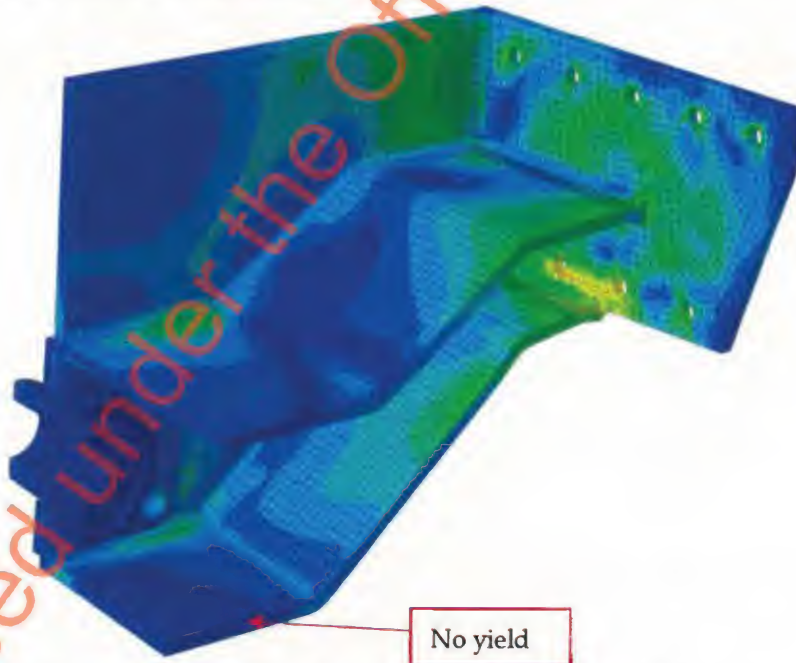
After load removal, the finite element analysis showed areas of the drawbeam had permanent deformation (plastic yield).

Figure 33 Areas showing plasticity after removal of load (colour other than indicator)

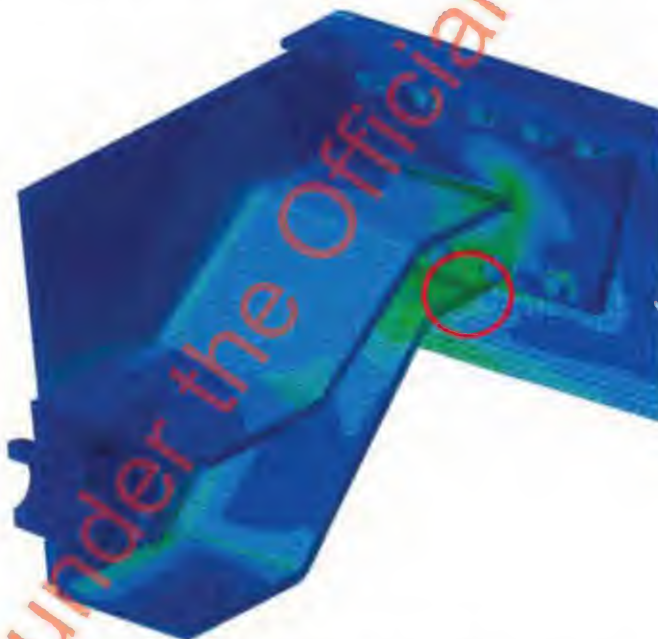
The stress in the drawbeam with the load in the forward direction, at the bottom flange to side plate rear connection, was 265 MPa of compressive stress, Figure 39.

Figure 39 Forward (tension) direction 110kN load, 265 MPa red circle

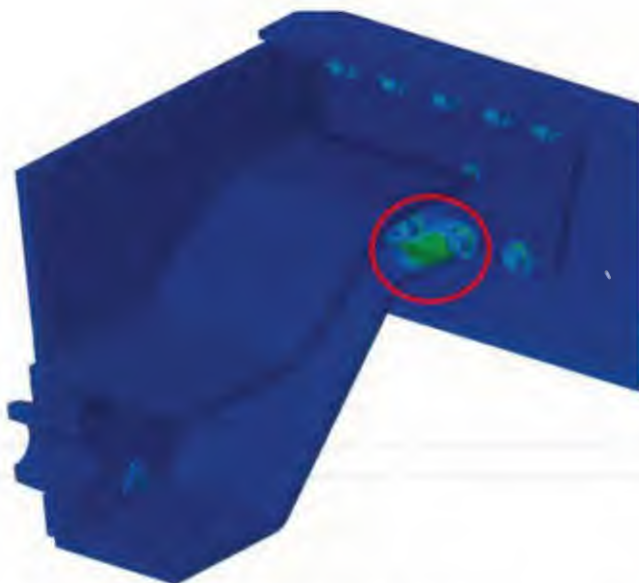
After removal of the load, a permanent deformation was predicted. This can be seen in the residual stress, Figure 40.

Figure 40 Residual stress from 110kN load, red circle

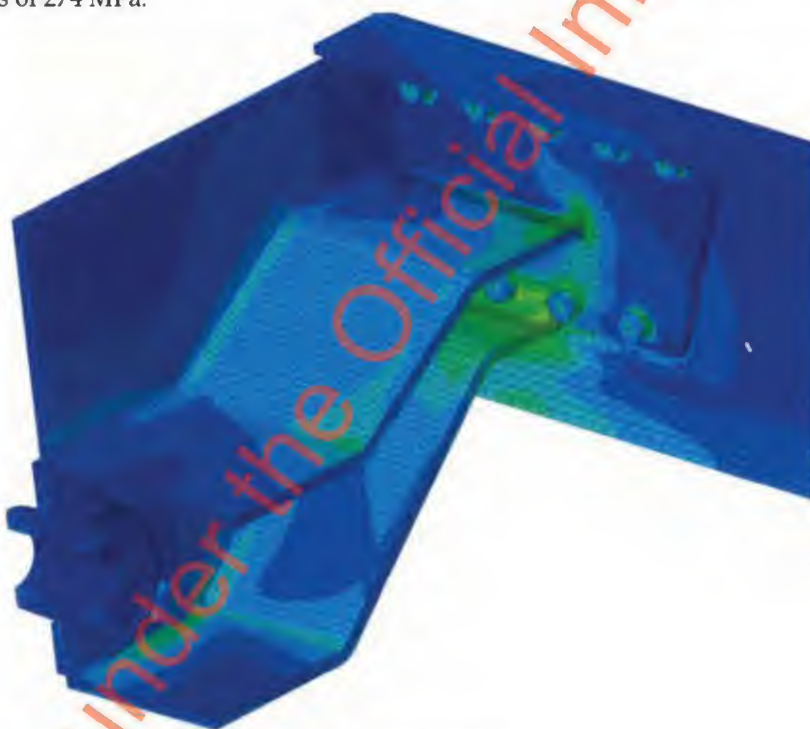
Under compressive load, the connection of interest is under tension and has a developed stress of 274 MPa.

Figure 41 Rearward (compressive) 110kN load, 274 MPa

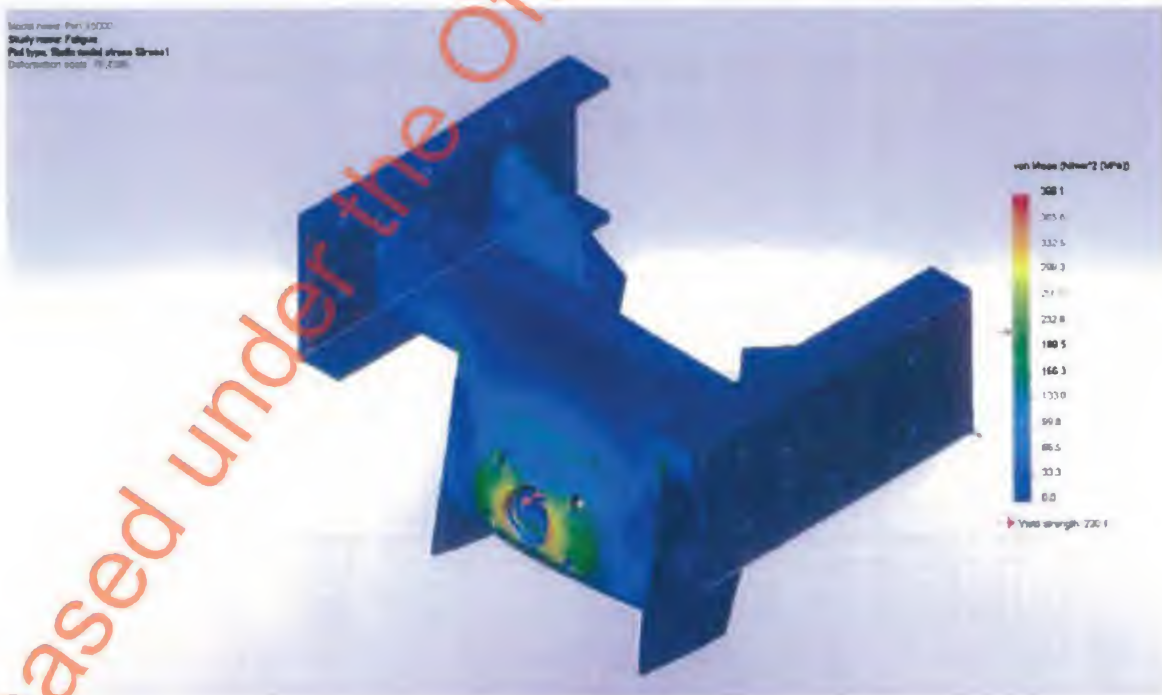
In particular the image below is from your certification file for LT400 348824. For fatigue compliance stress should be no more than 60% of yield strength according to AS 3990, however the FEA image shows stress levels above yield. Is this correct, and if so why did you proceed to certify the drawbeam?

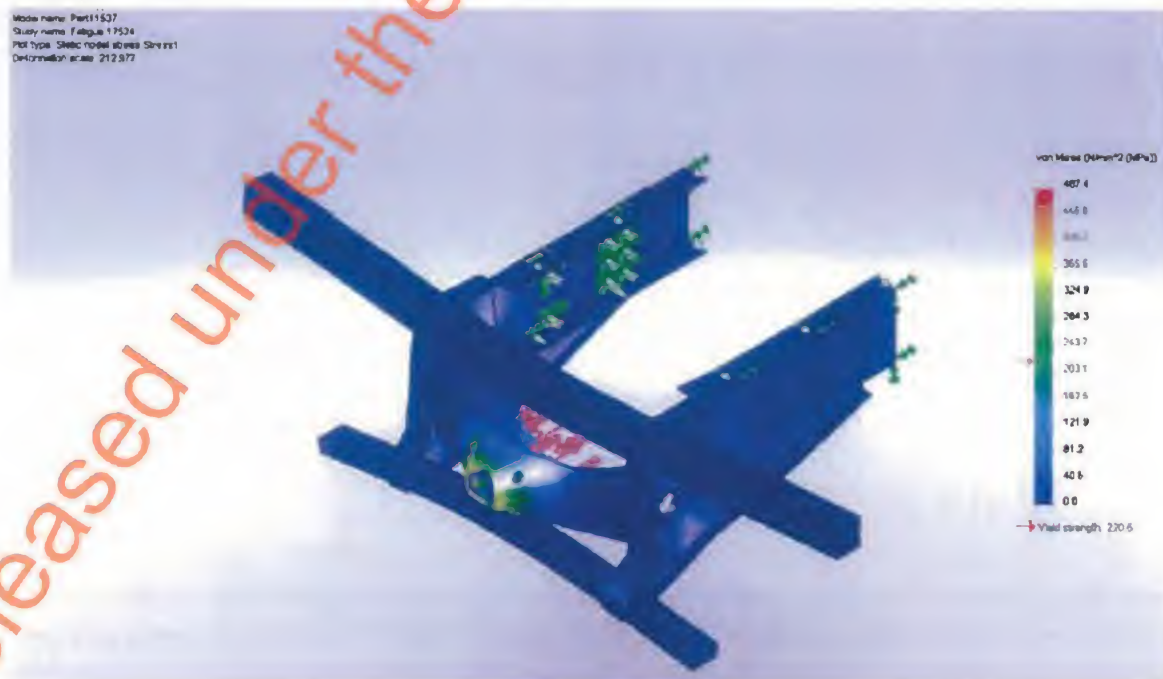
LT400 476767 - Registration number [REDACTED]

In particular the image below is from your certification file for LT400 476767. According to AS 3990, for fatigue compliance stress should be no more than 60% of yield strength, however the FEA image shows stress levels above yield. Is this correct, and if so why did you proceed to certify the drawbeam?

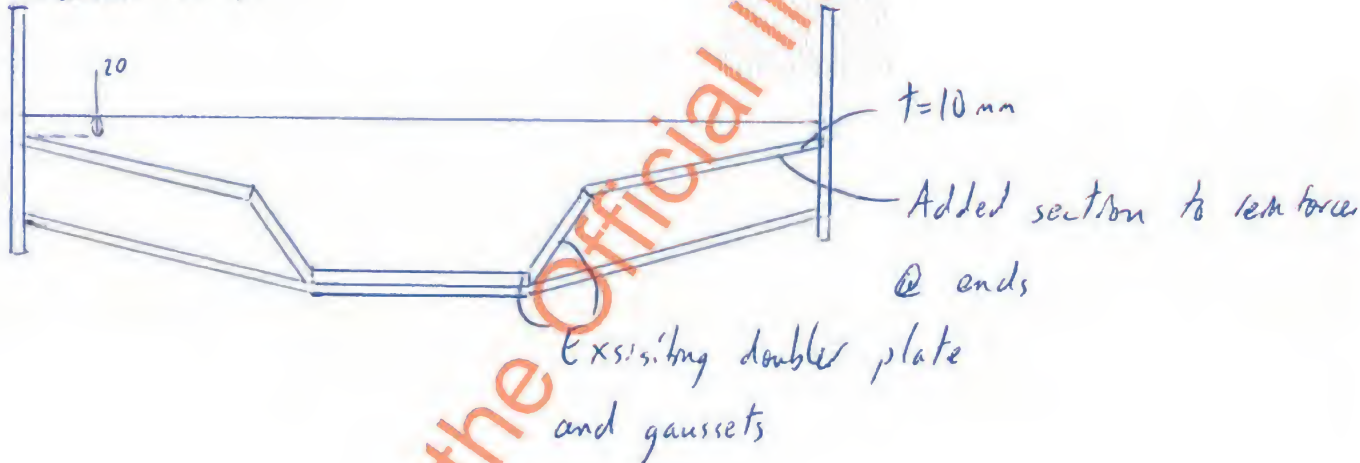
High mileage with  
high fatigue  
decided to scrap  
beam and give new  
beam
